12 JANUARY 2004

Maintenance

**ADVANCED COMPOSITE MATERIALS
MISHAP RESPONSE**

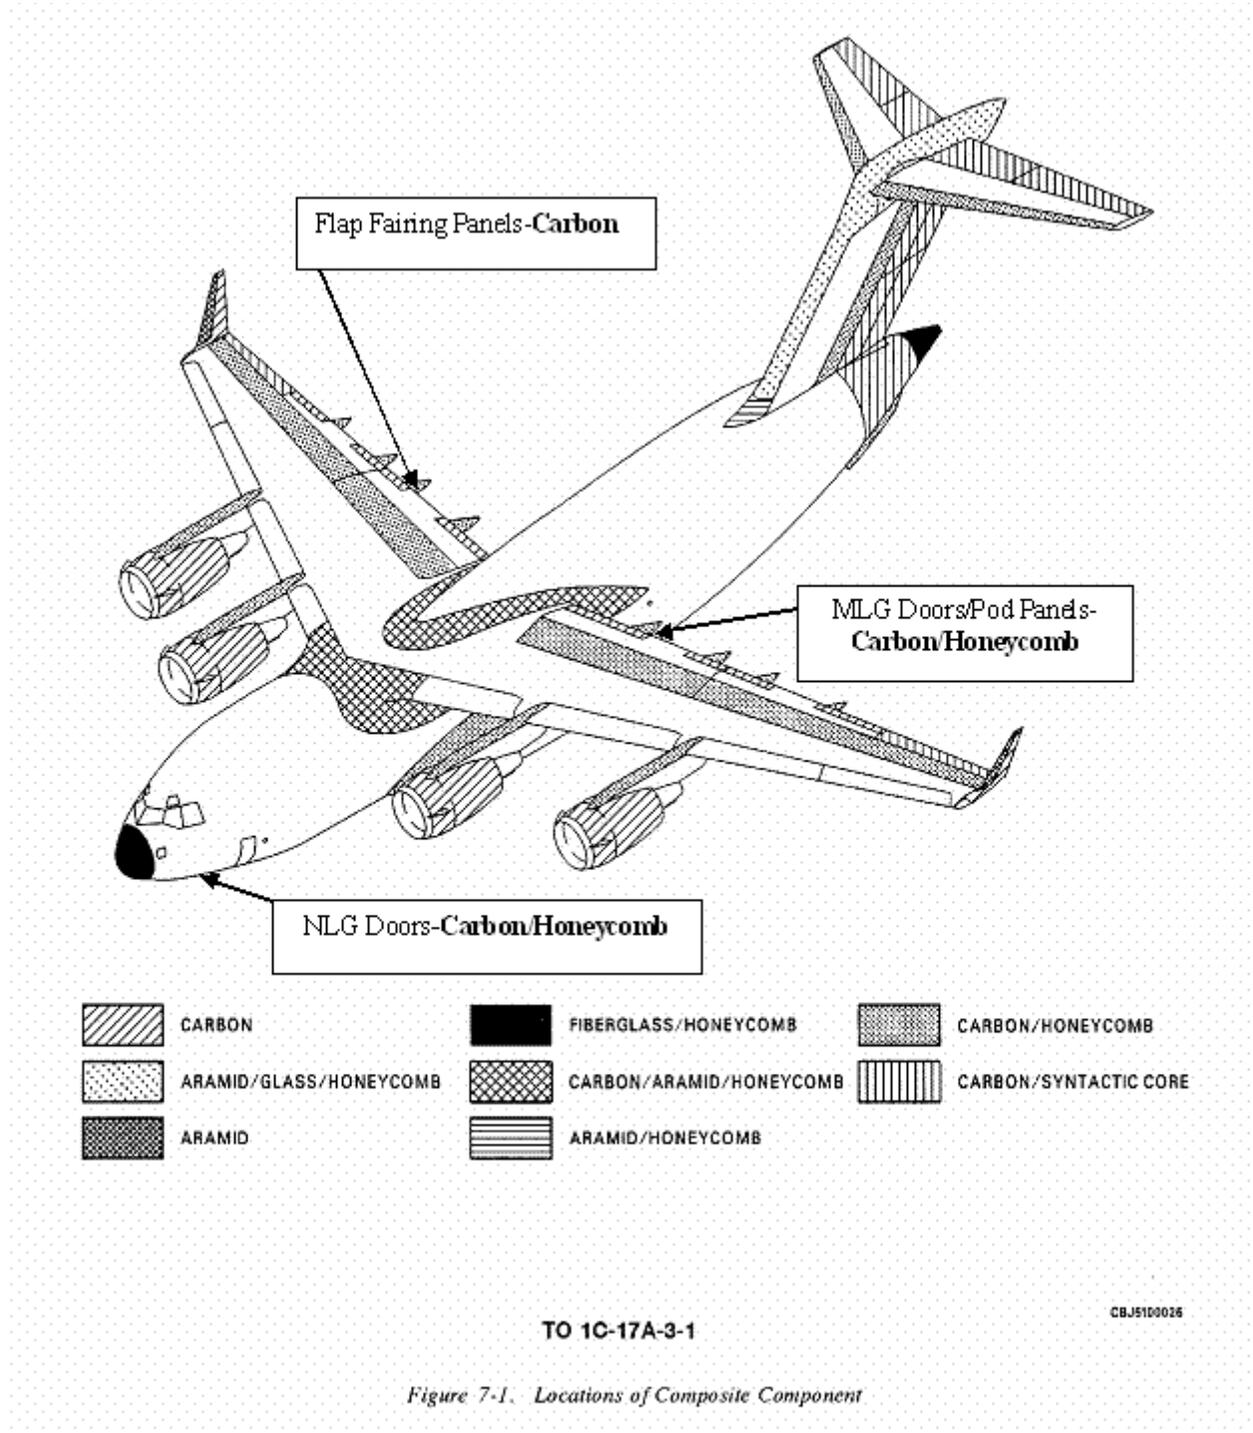
Attachment 3

C-17 COMPOSITE LOCATIONS

1.1. Carbon fibers are very light, become easily airborne, and are respirable. Plume dissipation under windy conditions increases dispersion area. Fire exposed carbon fibers break into shorter lengths and smaller diameters, increasing the probability for respirability and ease of transport. Inhaled carbon fiber particulate cannot be expelled efficiently. Absorbed pyrolysis products on carbon fibers allow toxic debris to enter the body, causing decreases in respiratory efficiency and increases passageway irritation. The combined effect of inherently sharp and stiff individual carbon fibers promotes easy dermal penetration. Partially pyrolyzed fibers easily break into smaller segments. Rubbing of exposed skin areas increases the affected area. Typical exposure requires medical attention for dermatitis. C-17A aircraft contain over 8% carbon/graphite epoxy materials by weight (15,000 pounds). (See **Attachment 3** for locations)
